New Hampshire Volunteer Lake Assessment Program

2003 Biennial Report for Powwow Pond East Kingston

NHDES Water Division Watershed Management Bureau 29 Hazen Drive Concord, NH 03301

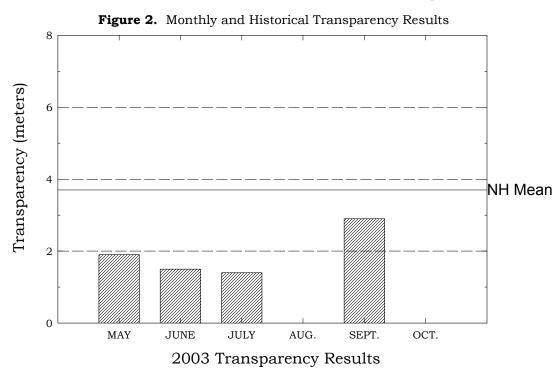
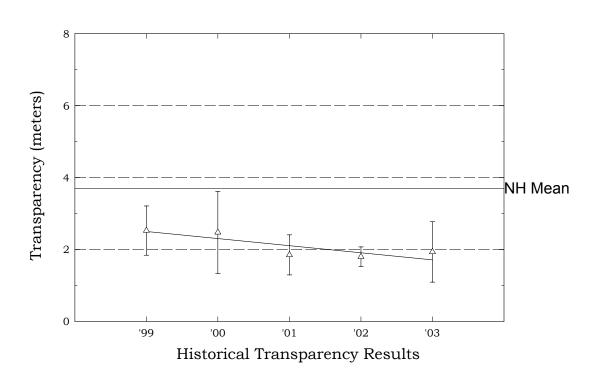
The current year data (the top graph) show that the in-lake transparency **decreased** from May to July, and then **increased** in September. The transparency in all four months was **less than** the state mean.

The bottom graph shows historical annual mean transparencies. In 2003, the mean transparency is *less than* the state mean.

Overall, visual inspection of the historical data trend line (the bottom graph) shows **a decreasing** trend for in-lake transparency, meaning that the transparency has **worsened** since monitoring began. After 10 consecutive years of sample collection, we will be able to conduct a statistical analysis of the historic data to objectively determine if there has been a significant change in the annual mean transparency since monitoring began.

Typically, high intensity rainfall causes erosion of sediments into lakes/ponds and streams, thus decreasing clarity. Efforts should continually be made to stabilize stream banks, pond shorelines, disturbed soils within the watershed, and especially dirt roads located immediately adjacent to the edge of tributaries and the pond. Guides to Best Management Practices designed to reduce, and possibly even eliminate, nonpoint source pollutants, such as sediment loading, are available from DES upon request.

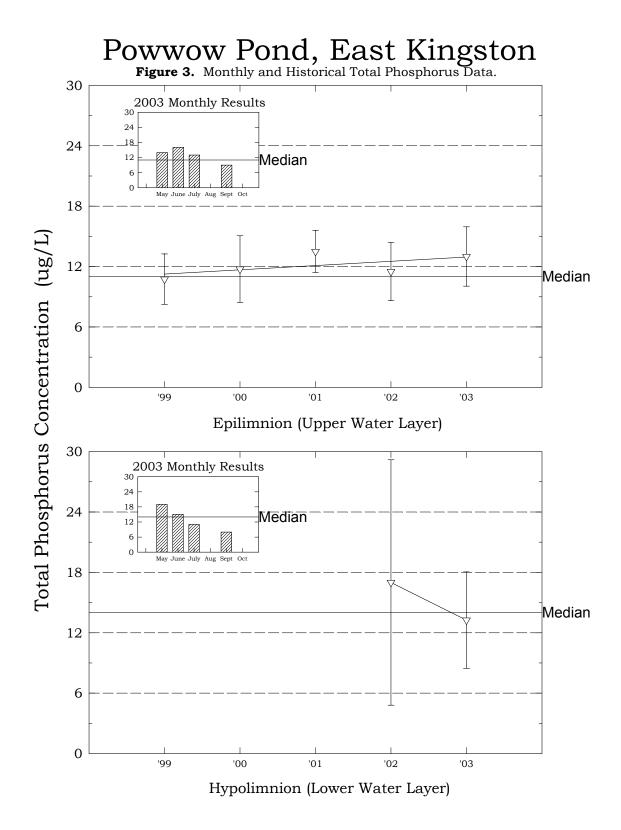
The current year data for the epilimnion (the top inset graph) show that the phosphorus concentration *increased* from May to June, and then *decreased* from July to August. The phosphorus concentration in May, June and July was *greater than* the state median while in September it was *less than* the state median.

The top graph shows historical annual mean epilimnetic phosphorus concentrations. In 2003, the mean epilimnetic phosphorus concentration is *greater than* the state median.

The current year data for the hypolimnion (the bottom inset graph) show that the phosphorus concentration **decreased** from May to September. The phosphorus concentration in May and July was **greater than** the state median, while in September it was **less than** the state median.

The bottom graph shows limited historical annual mean hypolimnetic phosphorus concentrations. In 2003, the mean hypolimnetic phosphorus concentration is *less than* the state median.

Overall, visual inspection of the historical data trend line for the epilimnion show **an increasing** phosphorus trend, which means that the concentration has **worsened** in the epilimnion since monitoring began.

Overall, visual inspection of the historical data trend line for the hypolimnion shows, with limited data, **a decreasing** phosphorus trend, which means that the concentration has **improved** in the hypolimnion since monitoring began.

One of the most important approaches to reducing phosphorus loading to a waterbody is to continually educate watershed residents about its sources and how excessive amounts can adversely impact the ecology and value of lakes and ponds. Phosphorus sources within a lake or pond's watershed typically include septic systems, animal

waste, lawn fertilizer, road and construction erosion, and natural wetlands.
